DEPARTMENT OF COMMERCE
CIVIL AERONAUTICS ADMINISTRATION
WAR TRAINING SERVICE
Washington

N3N-3

SERVICE BULLETINS AND ENGINEERING CHANGES

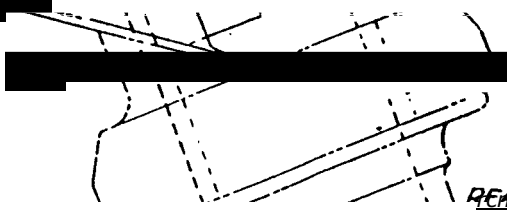
The tail wheel assembly, part No. 67709-2, should be inspected for excess wear of the tail wheel locking-pin holes in the caster cap, part No. 67709-32, and in the locking pin housing tube, part No. 68155-3.

When the tail wheel locking pin holes in the caster cap and the locking pin housing tube of the subject model airplanes become worn in excess of .010", repairs to the tail wheel locking assembly shall be made as follows:

PRESENT 4 S1 EM6LY
OF LOCK

REAM FOR BUSHING: 2-HOUSING-LOCK
